## TECHNICAL ANALYSIS

Tank Seam Road  
Co-Op Mining Company  
Bear Canyon Mine  
ACT/015/025

July 20, 1994

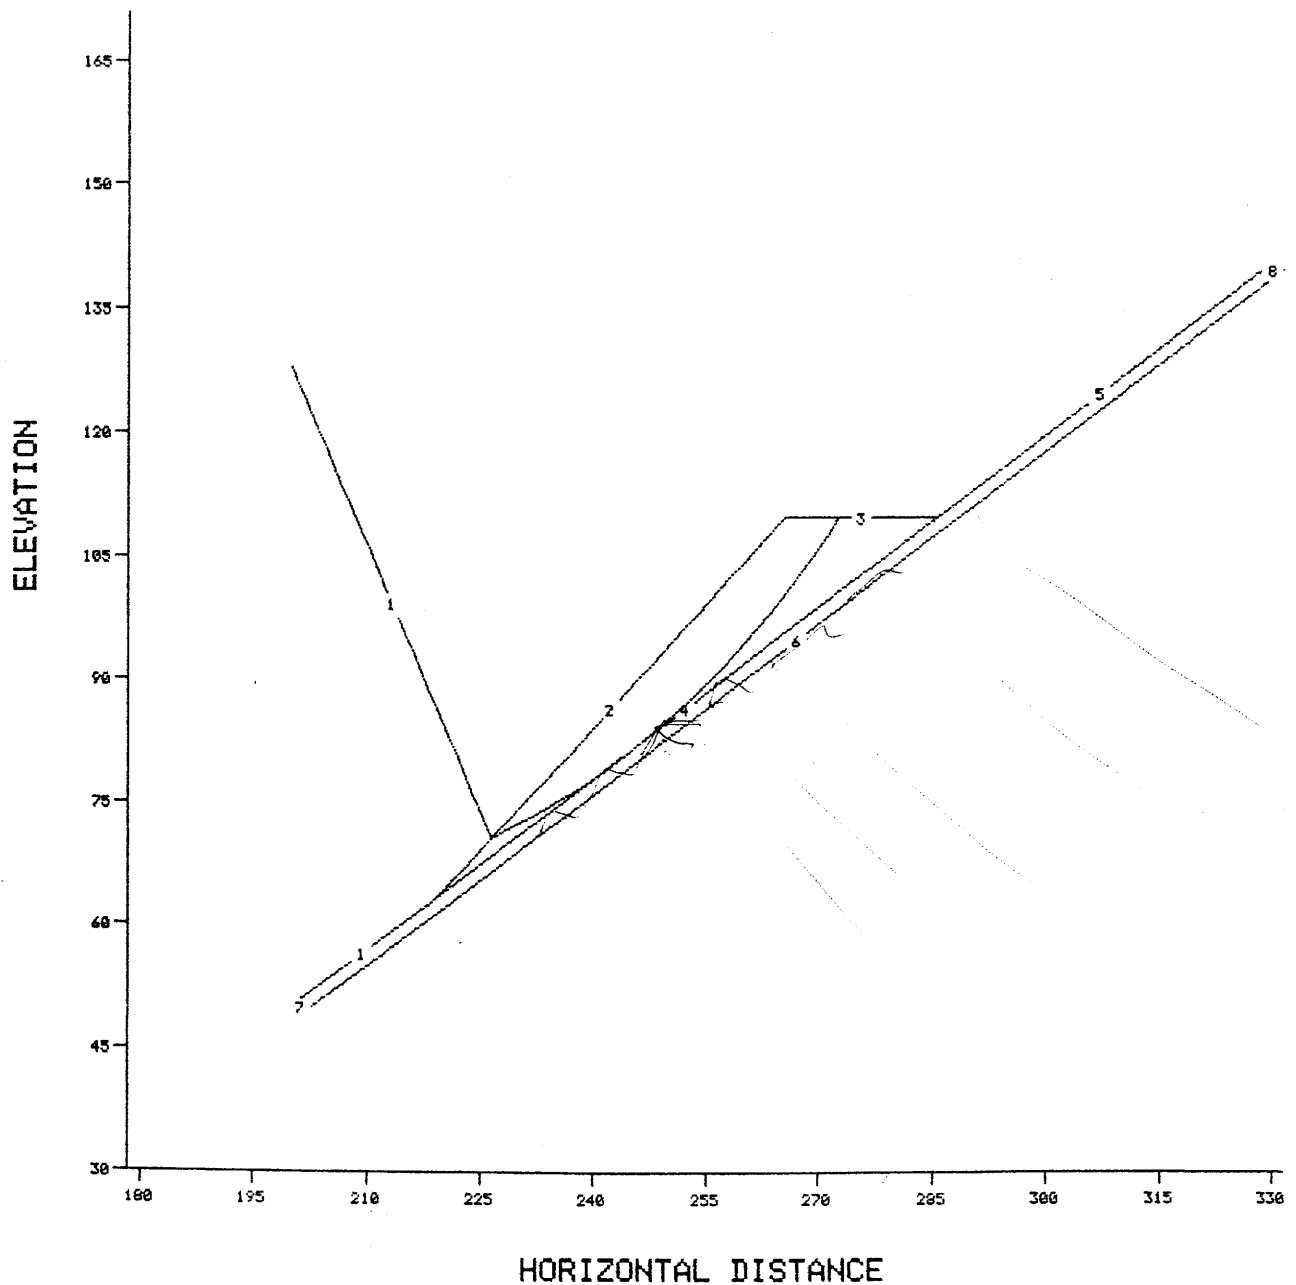
COMPLETE SLOPE CROSS SECTION

CIRCLE	X	Y	RADIUS	FS
1	179.0	173.5	113.2	1.31

When Dames and Moore learned of the low safety factor they revised their assumptions about the slope's profile. They claimed that if the slope was modeled with bedrock steps then the safety factors would be satisfactory. Dames and Moore did not supply the Division with any information on the steps spacing or demonstrate that the steps would prevent failure.

When the Division analyzed the slope using Dames and Moore revised assumptions the safety factor was 1.31. When saturated soil conditions were assumed the safety factor dropped to 1.29. The regulations require road embankments to have safety factors no less than 1.3.

The bedrock step spacing is important. The Division has demonstrated that if a 40 gap in the bedrock can result in a safety factor of 1.2.????????? While Dames and Moore's assumption about steps may appear reasonable they have supplied the Division with no information that such conditions will occur on all fill surfaces.

In the model the fill did not fail because it has high strength parameters. The strength parameters were based on one soil sample. If the parameters are decreased slightly then the fill failures have the required safety factor.
